Tasmanian BPL Trial – RF Susceptibility Tests

By Justin Giles-Clark VK7TW

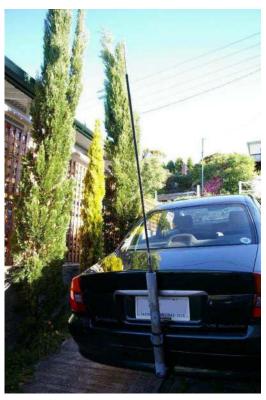
Appendix 1 - Mobile Antenna and Mount

MobileOne M20-1 (14MHz) Helical Vertical on towbar mount

- Tranceiver used was a Yaesu FT847 into a MobileOne M20-1 helical vertical antenna mounted on the towbar (see appendix 1), the power meter was a Revex W560.

- Polarisation of the transmitting antenna (vertically polarised shortened mobile antenna) and the receiving antenna (horizontally polarised powerlines) were not matched. Larger horizontally polarised wire or directional antennas may affect the BPL network even more. See appendix 1 for picture of antenna used.
